Surface Inspection of Flat Glass

G/Glas Glass inspection

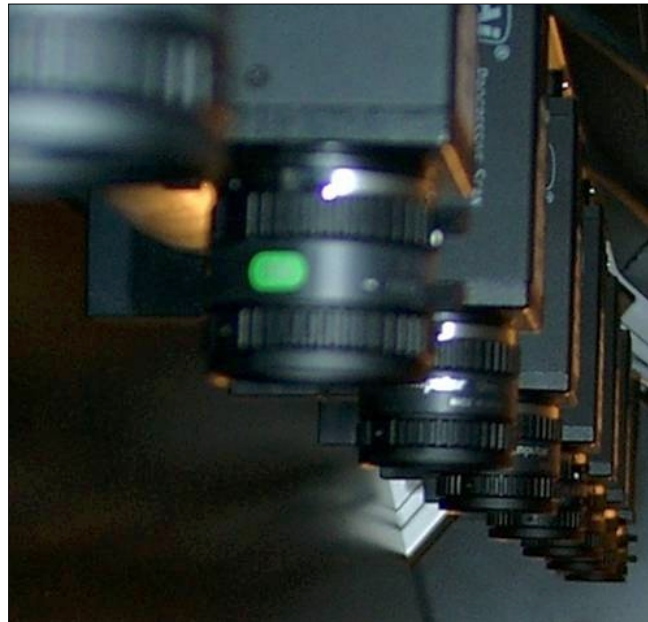
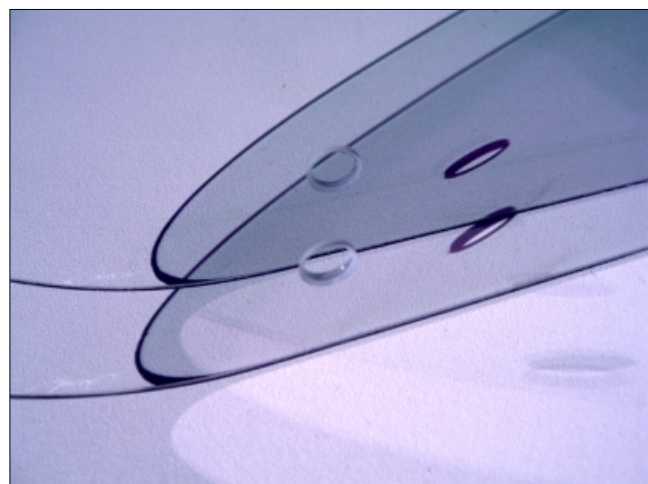
Image acquisition is done by multiple camera systems mounted above the manufacturing line. Thanks to state-of-the-art high performance illumination is reached an optimum of throughput at highest recognition reliability. The system is adaptable to the inspection of pattern glass used in photovoltaic applications by a purpose-built illumination system.

For tasks with moderate requirements according the throughput the acquisition unit is moved automatically at right angles to the conveying direction of the glass. This option reduces the hardware effort and allows a high magnification even for large glass.
